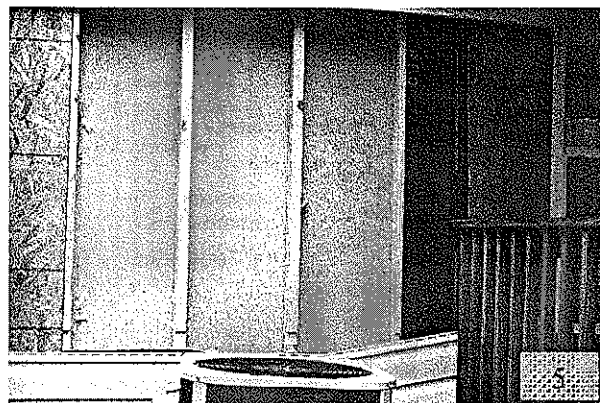
Photo 5: The master bathroom back wall sample -MS (10-24-07) ■8- is located behind the sink on the back wall. There was visual observation of previous apparent mold growth on the cavity side paper facing of the gypsum wallboard. (A large section of the exterior wall was removed to discover the nature of the staining.) The cavity conditions were dry at the time of this inspection. The primary suspected cause of this historic moisture damage was a known plumbing failure and resulting flood that occurred behind the visible staining as reported by the owner. Healthy Homes sample location -(HHR 5-22-06) ✕3-.

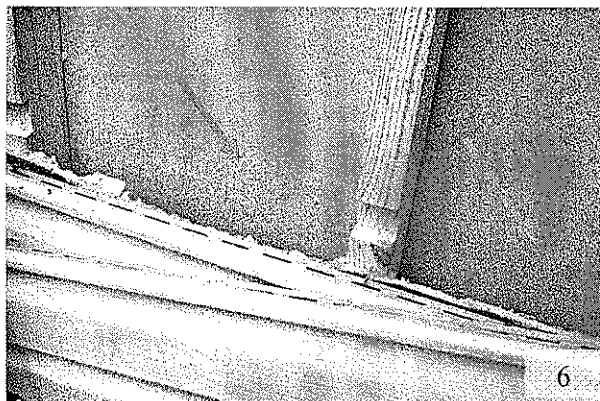
Photo 6: Red arrows point to observation of a distinct horizontal saturation line and area at the bottom of the wall cavity indicating that the leak was substantial enough to cause prolonged wetting of the gypsum wallboard and vertical wicking of standing water. It is not uncommon for flood damaged gypsum board to wick water up the entire height of the wallboard through capillary action.

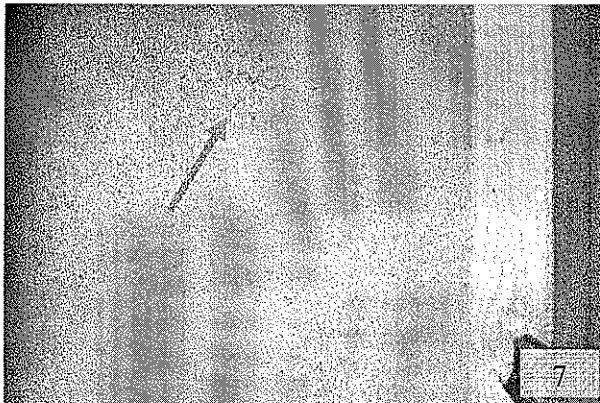
Photo 7: This wall stud bay adjacent to the sink was reported as "soft"; however, this wall had been previously impacted resulting in an indention that broke the board and paper backing. This will allow the board to flex with the appearance of being soft.

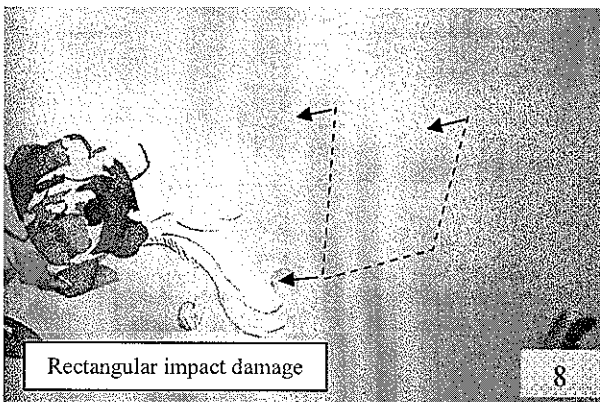
Photo 8: From inside the home damage to the wallboard is evident as a semi-rectangular impact. This wall is broken at this point and might appear to be soft. The impact indentation that broke the board and paper backing is clearly visible.

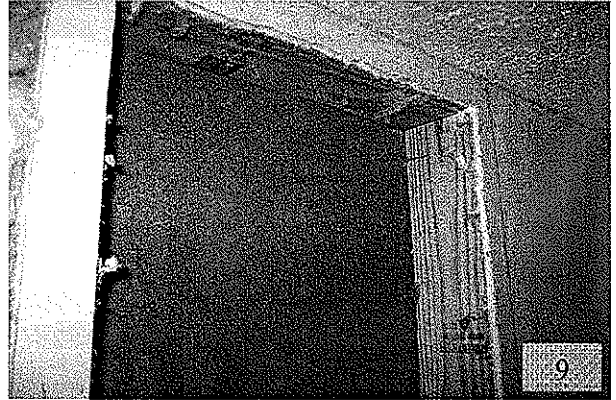
Photo 9: Samples of gypsum board cited as structurally damaged by HH were removed from the stud bay cavity from the end wall closet to be sent for structural testing. The interior of the stud wall cavity shows good practice in maintaining a substantially airtight wall cavity. No visible signs of damage were apparent; no signs of moisture, drip marks or possible fungal staining were evident.

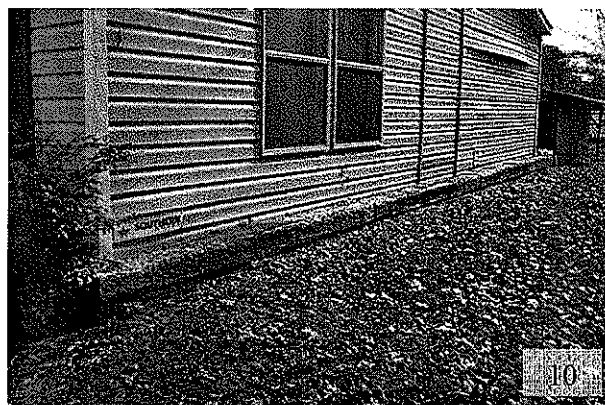
An unusual earth berm and railroad tie configuration created by the homeowner place the exterior walls at risk of earth and rainwater contact that could result in capillary moisture intrusion into the wall cavity. Video taken during simulated rain demonstrates this risk of bulk water entry. It is clear that the rail road tie placement results in direct rainwater entry into the crawl space due to splash behind the railroad ties.

Photo 10: All exposed walls (except those under the front and rear porches) are at risk of bulk water intrusion into the crawlspace due to the unusual landscaping. Railroad ties directly adjacent to the exterior walls are observed to splash rain water into the crawlspace and also prevent proper minimum crawlspace ventilation.

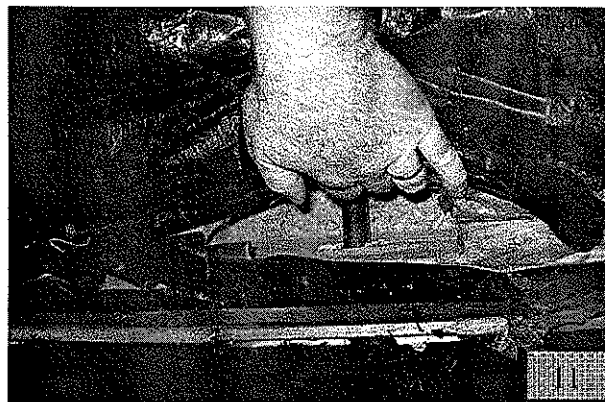
Photo 11: At this location, the bottom plastic of the home was found with a cut along the exterior wall - apparently in order to install a water faucet on site. The moisture level in this part of the plastic is elevated compared to other locations. By turning a water hose on at the roof to simulate rain, it is apparent that significant water splashes behind the railroad tie and enters the crawlspace. Rainwater or hose water directed near this wall can easily splash into the floor cavity and dampen the area under the master bathroom sink.

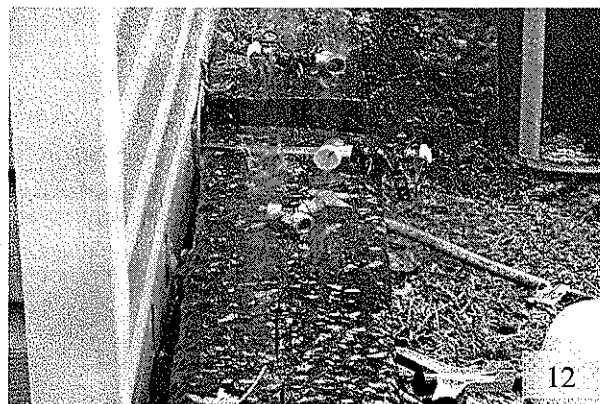
Photo 12: Splash from simulated rainwater shows how the railroad ties direct water under the home. The bottom plastic under the site-installed water faucet is torn allowing moisture to splash into the floor cavity area.

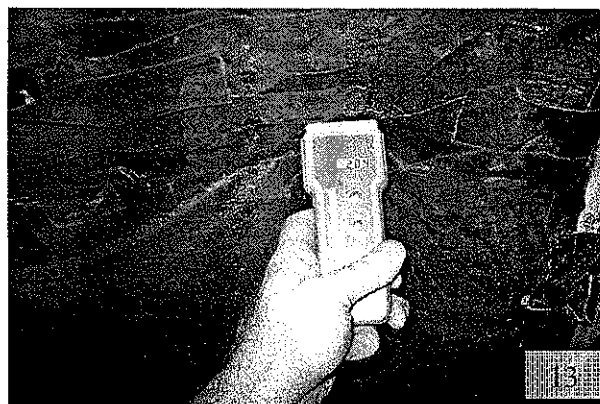
Photo 13: Moisture levels in the floor cavity insulation is higher (20% relative moisture level) than in other locations away from the splash area (10% relative moisture level).

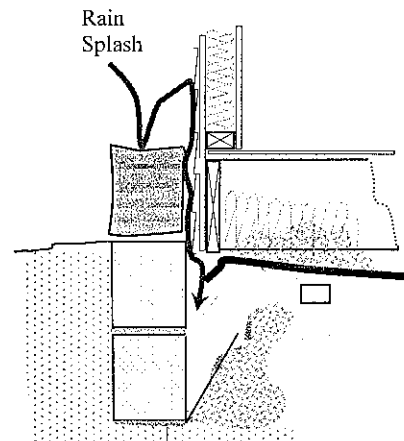
Sketch for Photo 12 & 13: Schematic of Murphy landscaping detail; rail road tie sits atop a non-structural concrete block wall. Splash can enter the floor cavity and communicate with the wood structural members.

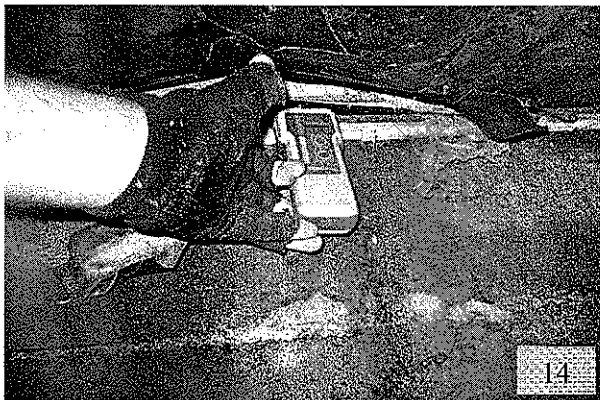
Photo 14: A pin meter shows wood moisture content of 18% in perimeter band joist under master bathroom sink area. This is a moisture management concern apparently resulting from splash into the floor cavity area. Such moisture will contribute to occasional elevated moisture in the master bathroom wall cavity.

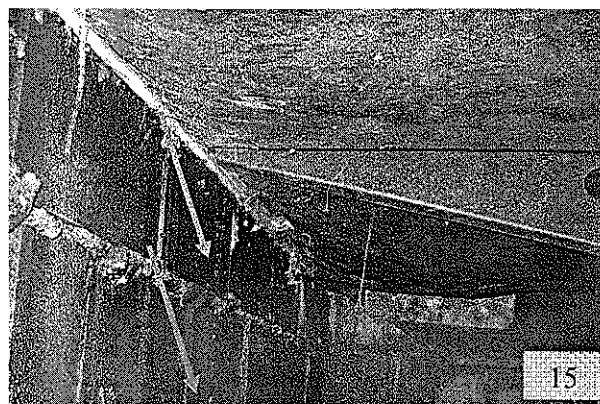
Photo 15: Water can be seen dripping in very close proximity to the torn bottom plastic near the faucet. Video taken of this shows the magnitude of water that splashes its way into the crawlspace at this location. This is the most likely explanation of elevated moisture levels in the insulation and surrounding floor timbers.

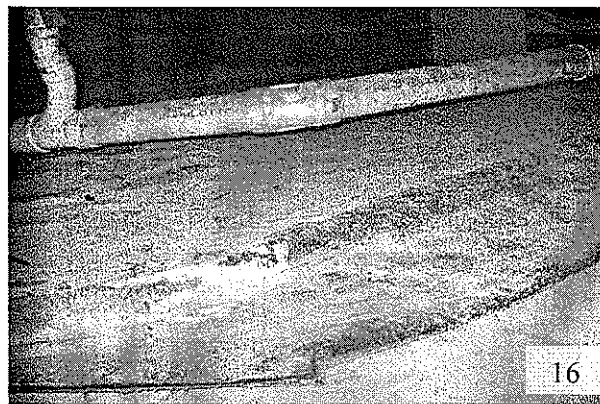
Photo 16: Heavy moisture stains throughout the crawlspace show that excess water entry is a persistent and long-term problem. Tan areas on black ground poly are mud sediment stains. White PVC drain pipe above is covered with suspected fungal stains.

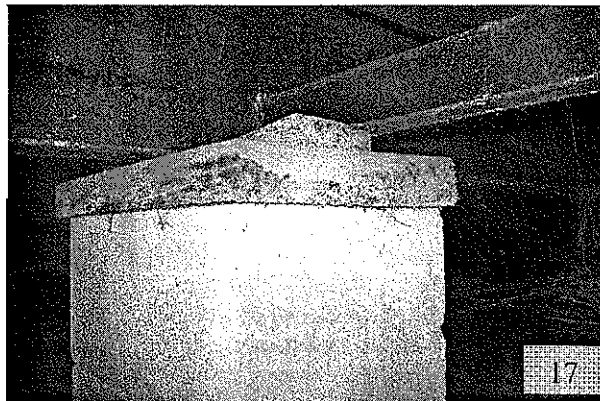
Photo 17: Wood spacer block and wedge at support pier are heavily stained with apparent fungal growth. This is due to the poorly vented crawlspace foundation and the consistent entry of moisture through the foundation walls.

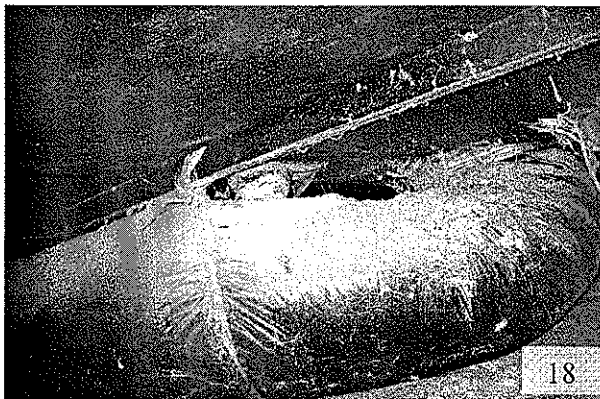
The crawlspace moisture level is exacerbated by the fact that the exhaust vent for the clothes dryer discharges directly into the crawlspace area.

Photo 18: Exacerbating the wet condition in the crawlspace is the fact the dryer vent discharges directly into the center of the crawl space area.

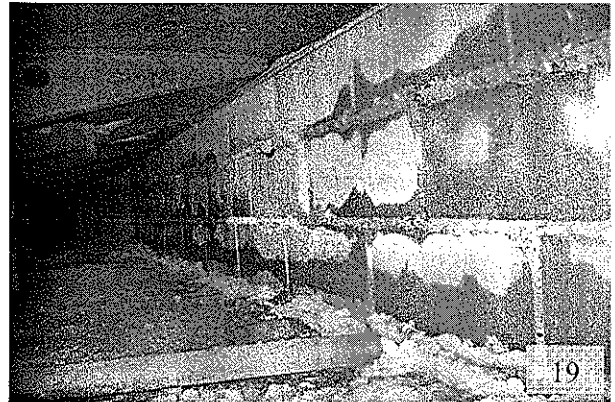
Photo 19: Front wall shows seepage through the block wall onto bare soil, creating excessive moist conditions in the crawlspace. Ground vapor plastic is not visible in this area.

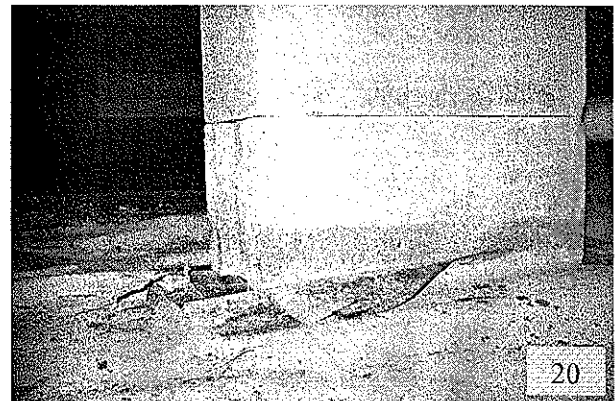
Photo 20: Crawlspace piers demonstrate stains from moisture moving up the block. This is further evidence of moisture in the crawlspace.

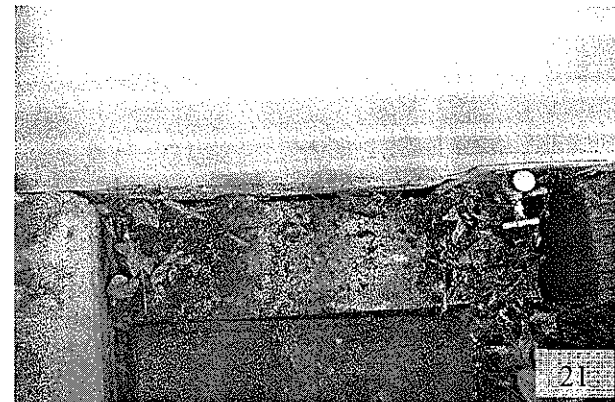
Photo 21: A small section of railroad tie has been removed to show the access into the crawlspace and the accumulated leaf litter and other debris.

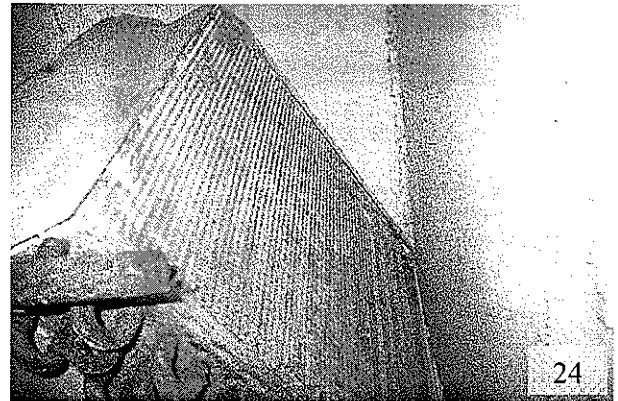
Photo 24: The A/C coil needs cleaning; other photos support that the HVAC equipment is not adequately maintained.

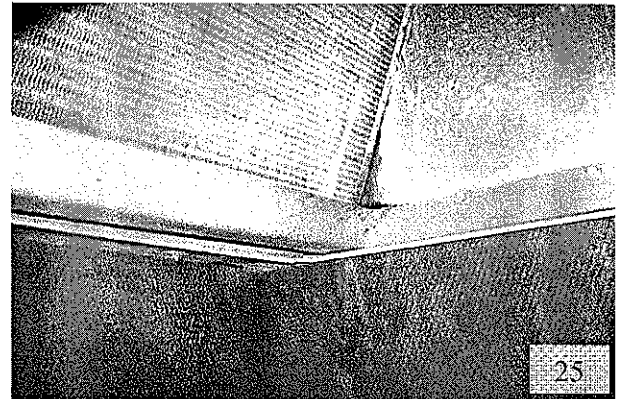
Photo 25: Rust stains below the condensate pan indicate past condensate overflows.

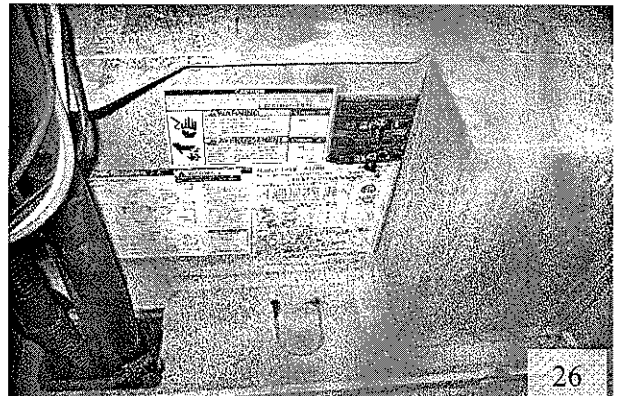
Photo 26: Water stains inside of the furnace cabinet indicate past condensate overflows.

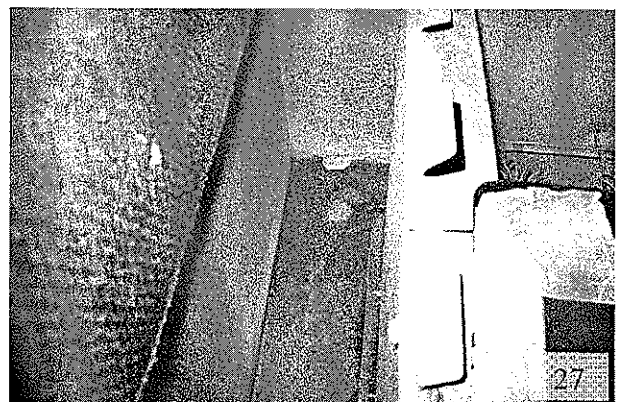
Photo 27: Sediment and water stains at the bottom of the furnace cabinet indicate past condensate overflows.

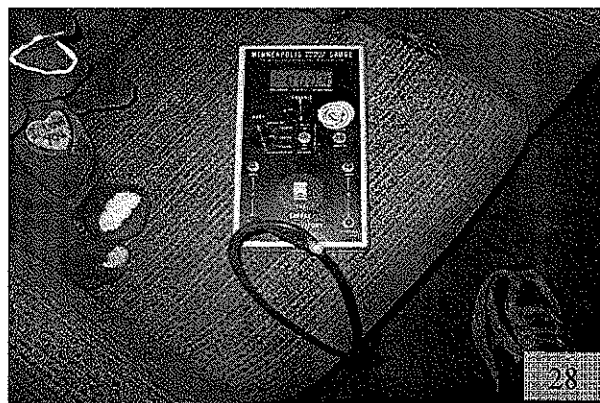
Photo 28: Pressure when the air handler was engaged the "system pressure" did not produce a negative pressure effect; rather the air handler had a neutral effect on the house pressures.

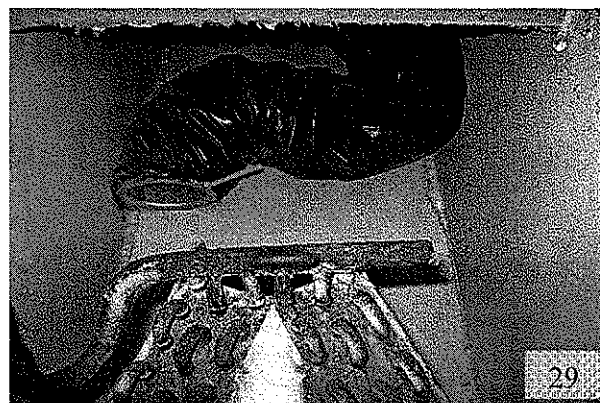
Photo 29: Fresh air ventilation is provided by a make up air duct that brings outdoor air to the return plenum above the furnace. The installation of the duct was acceptable; the extra curve in the flex duct will not result in significant flow reduction at the expected airflow. Observations showed that outdoor air was delivered through the ventilation duct when the furnace fan was engaged.

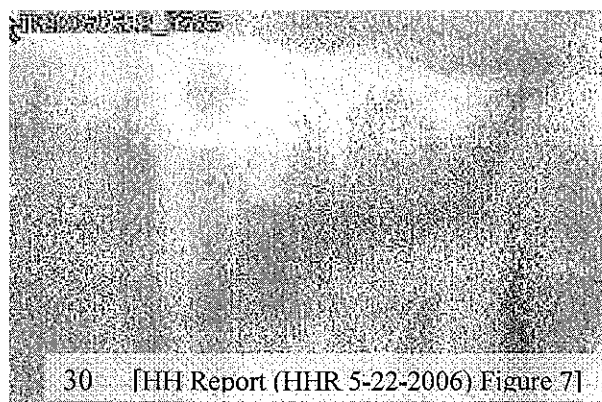
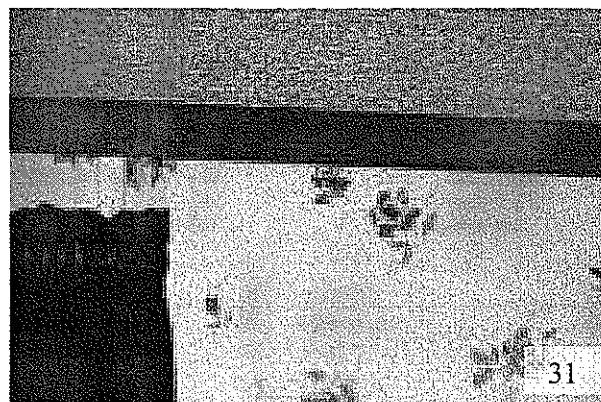
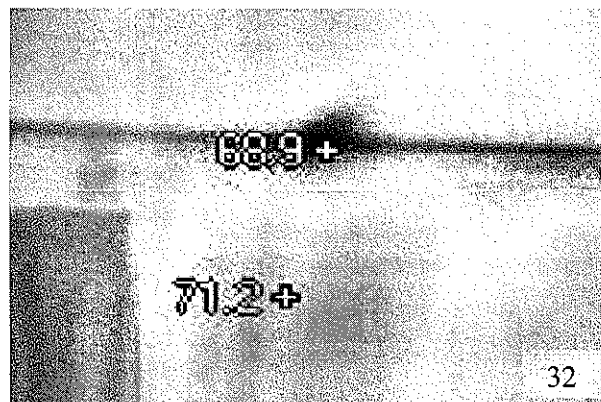
Photo 30: The HH Murphy home report indicates that the red color is an indication of "air/heat infiltration." This is a normal and expected image seen in any light frame construction where IR photos are taken during the daylight hours when sunlight can impact the images and confuse interpretation.

There is no way to tell by the thermal images provided by HH whether any "air/heat infiltration" is taking place within the wall cavities as is claimed. The temperature differences could have easily been caused solely by heat conduction from outside and insulation imperfections. It is improper to make the assumption that there is any indication of "air/heat infiltration" in this area as was reported in the Healthy Homes report.

Photo 31 & 32 reflect thermal bridging, where the more conductive wall top plate is conducting heat outwards. (This is a cold weather picture – thus the blue color represents heat loss.) The two superimposed images illustrated in Photo 32 show that the temperature differences between the blue and red colors is only 1.3°F; and in spite of the dramatic color variation is not significant.

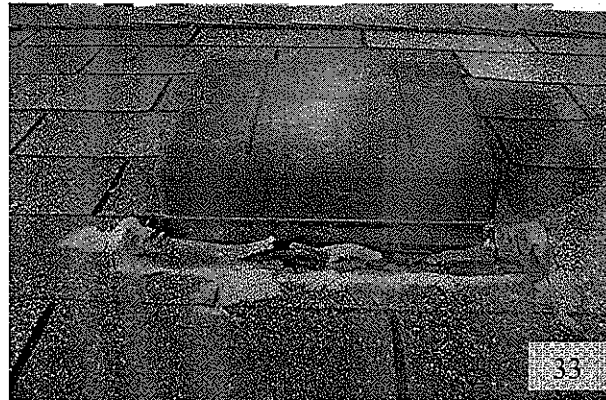
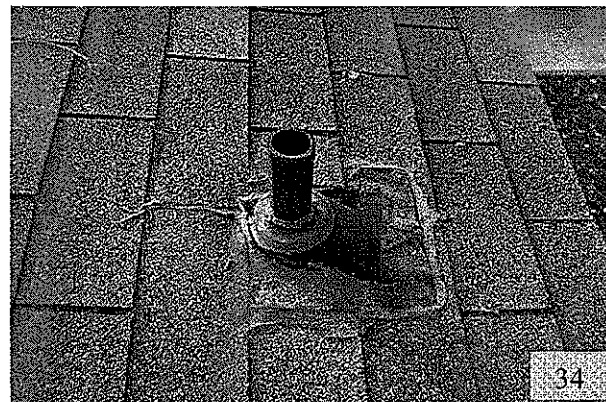
The sealing around almost all of the roof penetrations is beginning to deteriorate. Roof penetrations and flashings are typically required by the homeowner manual to receive periodic (annual) inspection and re-sealing. This 4-year home appears only to have the original factory sealing material, and maintenance/resealing should be provided. Delay of routine maintenance could result in water damage to the roof assembly and adjacent building components.

Photos 33 & 34: The sealing around almost all of the roof penetrations is beginning to deteriorate. This 4-year home appears only to have the original factory sealing material, and maintenance/resealing appears to be over due.
